RECORDS SEARCH & RISK ASSESSMENT

D & D FOODTOWN SUPERMARKET

**510 MAIN STREET
LINCOLN, MONTANA 59639**

**PROJECT NUMBER: 2019.508
DATE: SEPTEMBER 9, 2019**

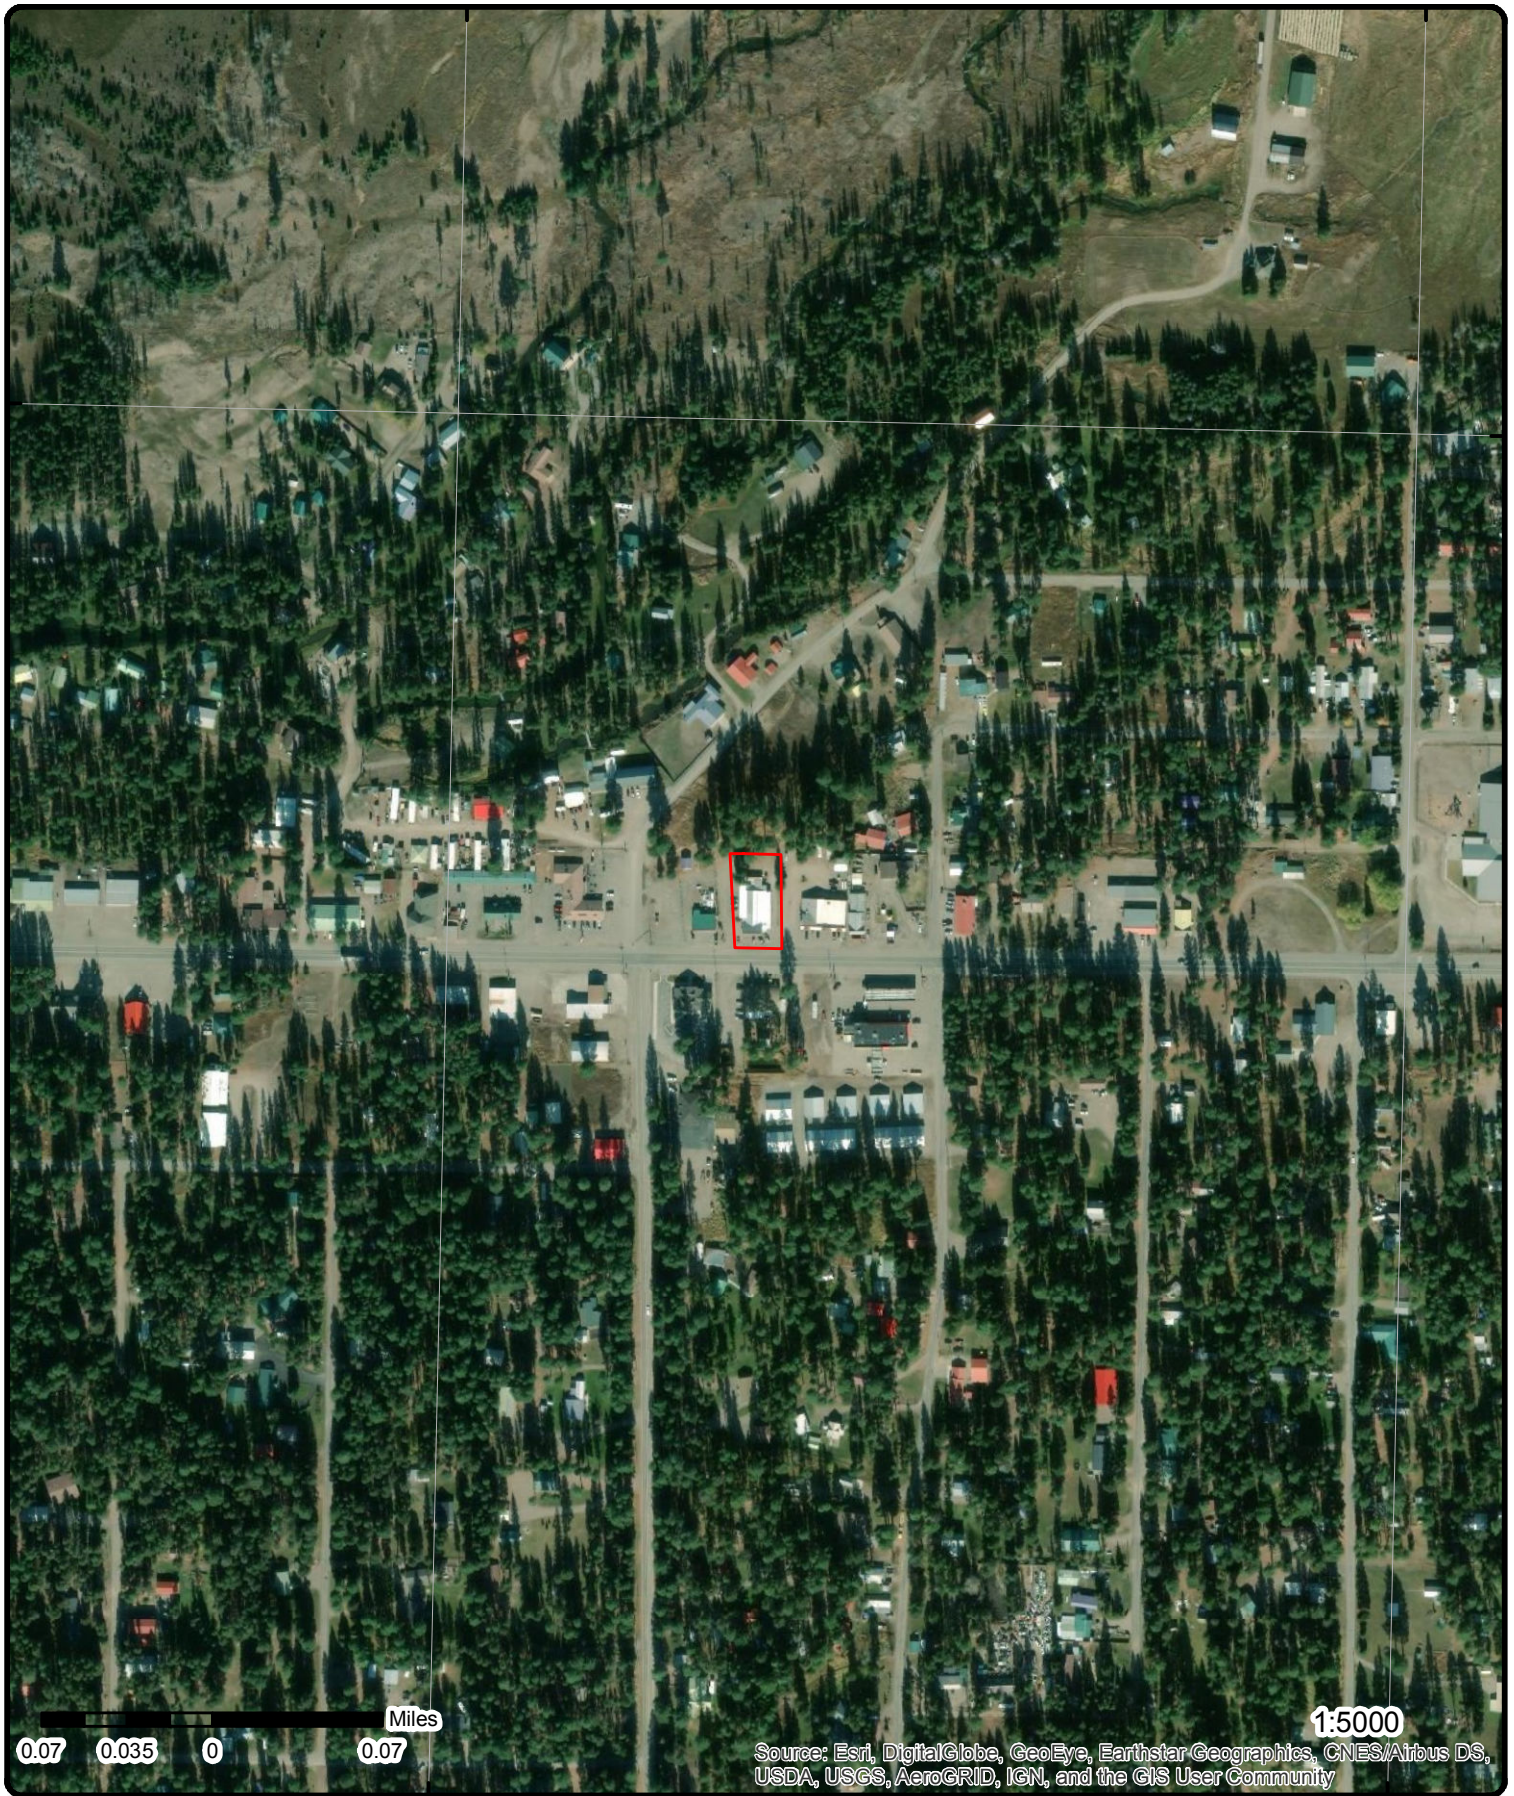
Aerial (2018)

Address: 510 Central AVE, Lincoln, MT, 59639

Available historical aerial photographs were reviewed for the years 1967, 1995, 2002, 2005, 2009, 2011, 2013, and 2015. The target property was constructed in 1962 and appears to be fully developed in its current configuration in all available historic aerial photographs. The north adjoining property is observed to be in its current configuration as vacant/forested land in all aerial photographs. The south adjoining property and the east adjoining property appear to be in their current configuration in 1967. The west adjoining property is observed to be developed but in a slightly different configuration in the 1967 and 1995 aerials. The property appears to be developed in its current configuration in the 2002 aerial. Based on A3E’s review of available online historical aerial photographs, no environmental concerns were identified for the *target property*.
